# Service Bulletin

Bulletin No.: 18-NA-279

Date: October, 2019

**Subject:** Passive Door Unlocking Inoperative and/or Enabling and Disabling of Passive Unlocking

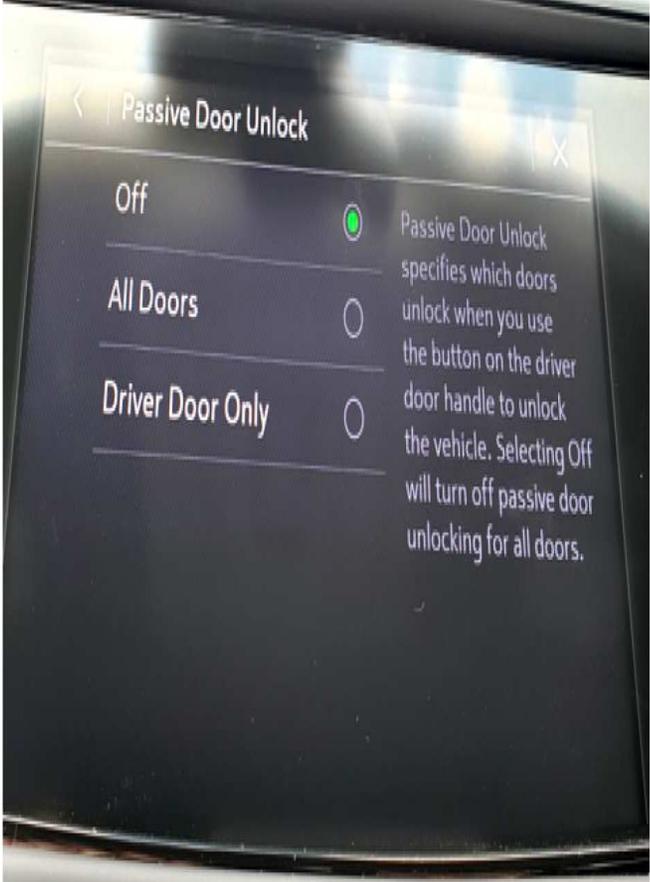
<p><b>Involved Region or Country</b></p>	<p>All Export Regions.</p>
<p><b>Condition</b></p>	<p>Some customers may comment that the passive door unlocking feature is inoperative when pressing the button on any door handle or tailgate release handle. They may also comment that all turn signals flash 4 times quickly when the button is pressed.</p>
<p><b>Correction</b></p>	<p>When using the following procedures, the owner can cycle between Passive Unlocking Enabled to Passive Unlocking Disabled, and back.</p> <p>Once any individual FOB is used to disable Passive Unlocking, Passive Unlocking will be disabled for ALL FOBs.</p> <p>Additionally, as shown below, some listed vehicles have "Passive Door Unlock" as a Vehicle personalization feature via the center stack. When selected, this option applies to ALL FOBs.</p>

Starting State	Do:	Results in:
Passive Unlocking is Enabled	Press and Hold both Lock and Unlock FOB buttons for 3 seconds.	Turn Signals flash 4 times and Passive Unlocking is Disabled. When the button on the door handle is pressed, the Turn Signals flash 4 – 2 times and the doors remain locked.
Passive Unlocking is Disabled	Press and Hold both Lock and Unlock FOB buttons for 3 seconds.	Turn Signals flash 4 times and Passive Unlocking is Enabled. When the button on the door handle is pressed, the door(s) will unlock.
